**Evaluation of Corrosion Resistance of New and Upcoming Post-Tensioning  
Materials After Long-Term Exposure Testing**

**Thesis**

The University of Texas at Austin

**December 2010**

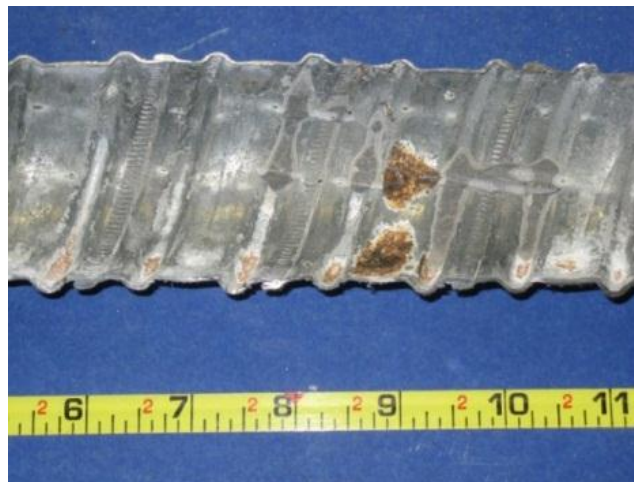
The north and south ducts both had localized severe corrosion damage. Most damage on the north duct occurred at midspan and at the live end quarter point. At these locations, the outside of the duct experienced severe pitting as well as some area loss on top of the duct only. This is shown in Figure 5.17. Pitting and corrosion were more extensive on the inside of the duct, extending nearly the full length of the duct on its top inside surface. The shape and extent of the damage indicate the presence of small grout voids along the top of the entire duct. Significant corrosion and pitting also extended along the bottom inside surface. Here, the location of damage suggests that voids may have formed under the strands during grouting (see Figure 5.16). The inner surface of the duct also showed discoloration along its entire length, especially where the strands had rubbed against it.

***Figure 5.16: Specimen T.1, Corrosion Along Gouges on Bottom Half of North Duct***

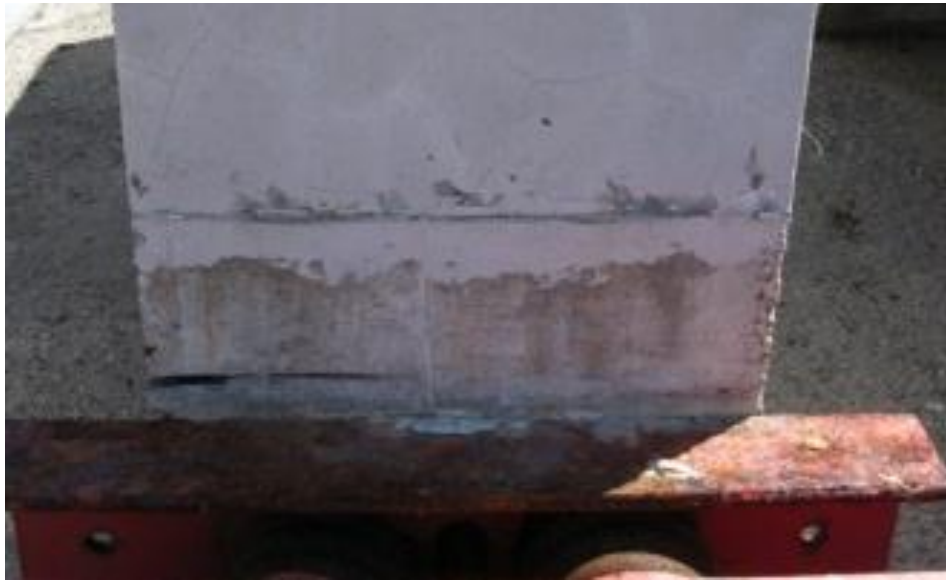
The specimen had two large transverse cracks running along its top face and down its north and south faces, each with an average width of 0.03 inches. The epoxy used to seal the vertical portions of these cracks to prevent leakage was intact. The transverse crack nearest to the dead end was not continuous across the specimen. One discontinuous longitudinal crack was present approximately 6 inches from the south face of the specimen. Its maximum width was 0.01 inches. This crack was not continuous. It was not visible within about six inches of the south grout vent. Similar to specimen T.1, a large crack had formed at the re-entrant corner of the dead end corbel during live load application<sup>7</sup>. This crack had been sealed with non-shrink mortar, which was still intact at the time of autopsy. The dead end anchorage pourback showed significant separation as well as some delamination near its interface with the rest of the specimen. This is shown in Figure 5.23. In addition, pattern cracking was found on the top and dead end surfaces of the pourback. This suggests the action of plastic shrinkage during the life of the specimen. Crack width data is shown in Figure 5.24, and the crack diagram is shown in Figure 5.28.

***Figure 5.23: Specimen T.2, Separation and Delamination Around Dead End Pourback***

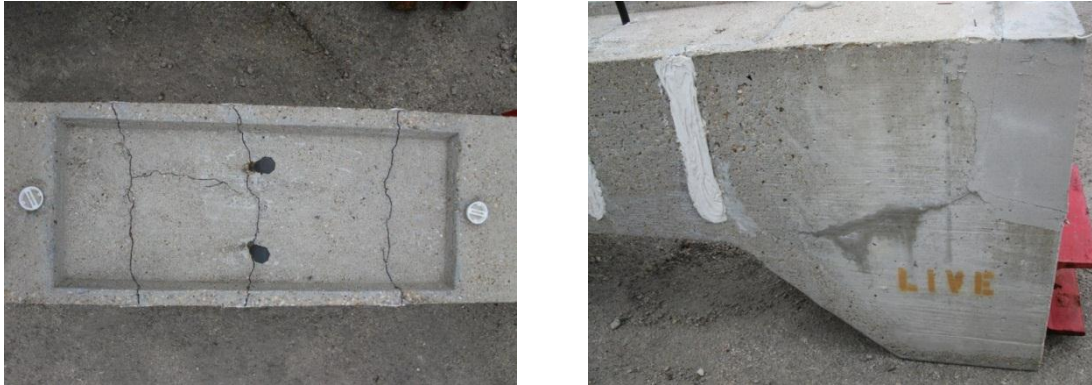
*Figure 5.33: Specimen 1.2 Top Surface (Left) and Leakage at Live End Corbel Crack (Right)*

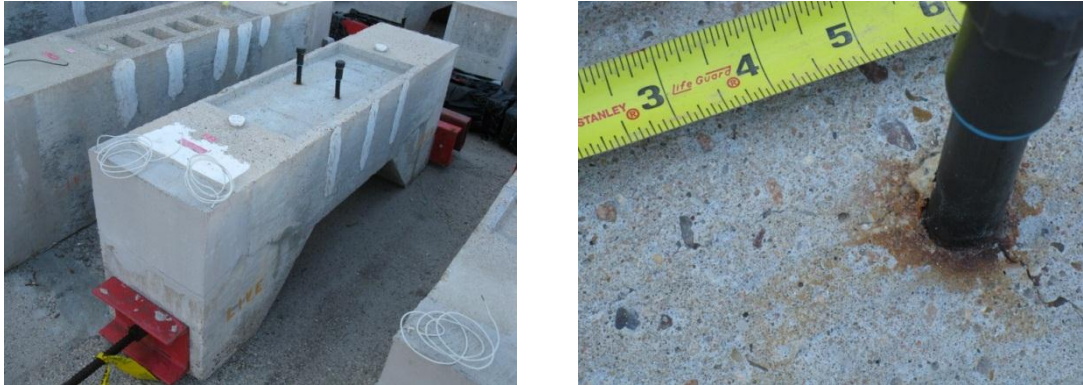
*Figure 5.43: Specimen 2.2 Overall (Left) and Corrosion Stains Near Grout Vent (Right)*

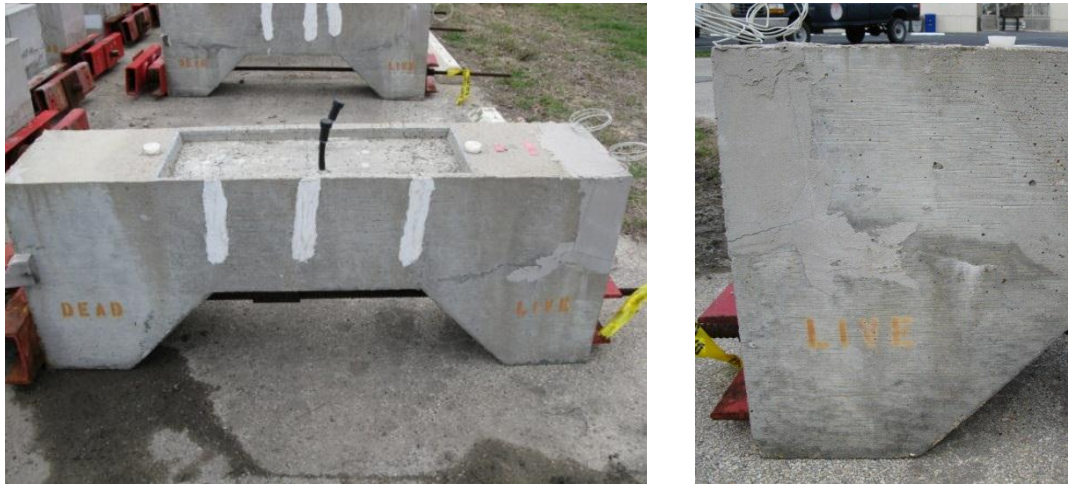
*Figure 5.74: Specimen 3.2 Overall (Left) and Efflorescence at Live End Corbel Crack*

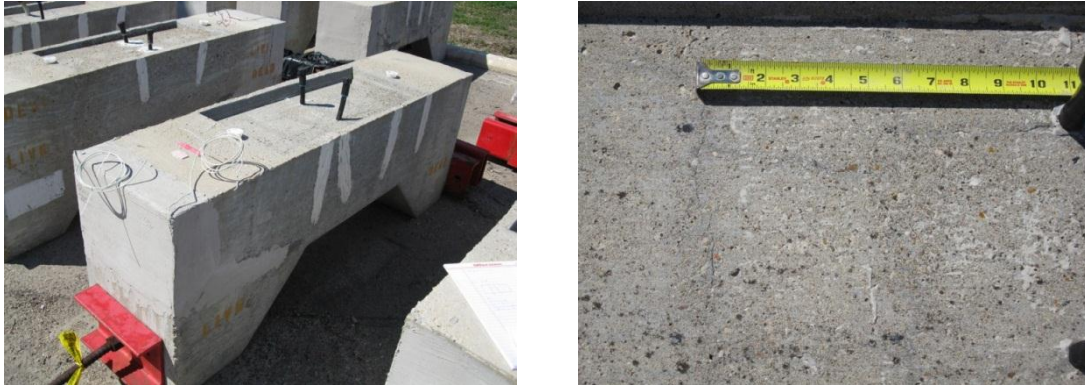
*Figure 5.86: Specimen 3.4 Overall (Left) and Discoloration Around Surface Cracks (Right)*

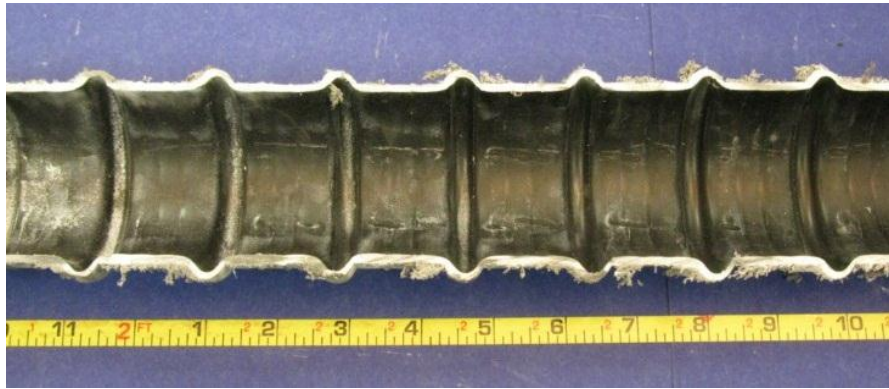
***Figure 5.89: Specimen 3.4, Strand Gouging on Bottom of North Duct***

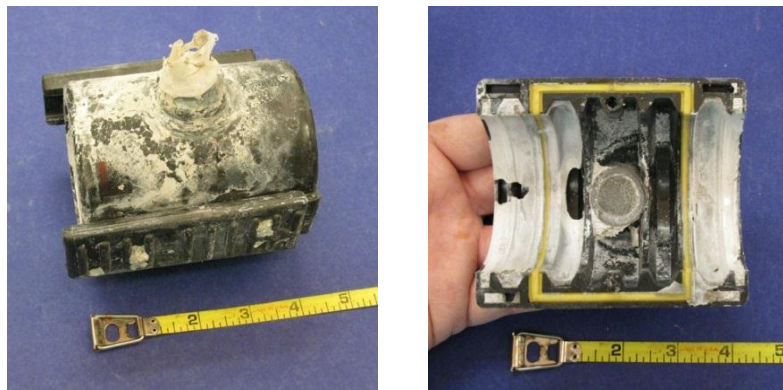
***Figure 5.90: Specimen 3.4 North Duct Coupler Outer Surface (Left) and Breach in Upper Gasket (Right)***

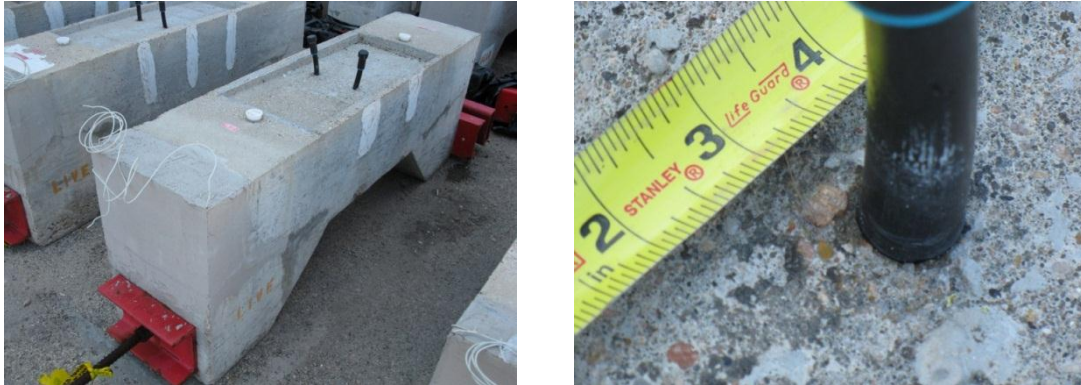
*Figure 5.96: Specimen 4.2 Overall (Left) and Discoloration Around North Grout Vent (Right)*

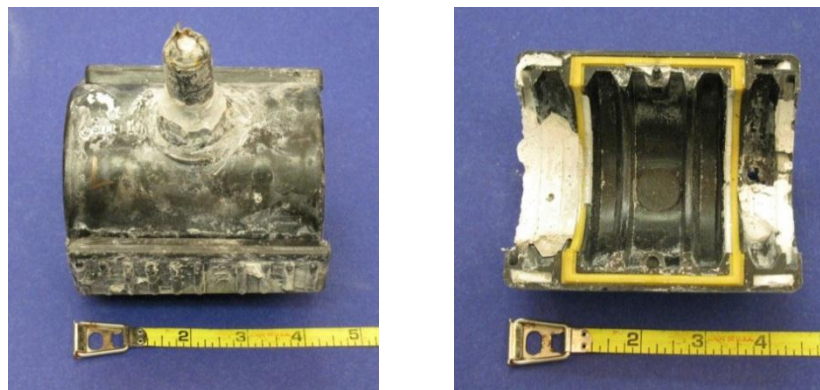
***Figure 5.99: Specimen 4.2 Coupler Outer Surface (Left) and Lower Gasket Breach (Right)***

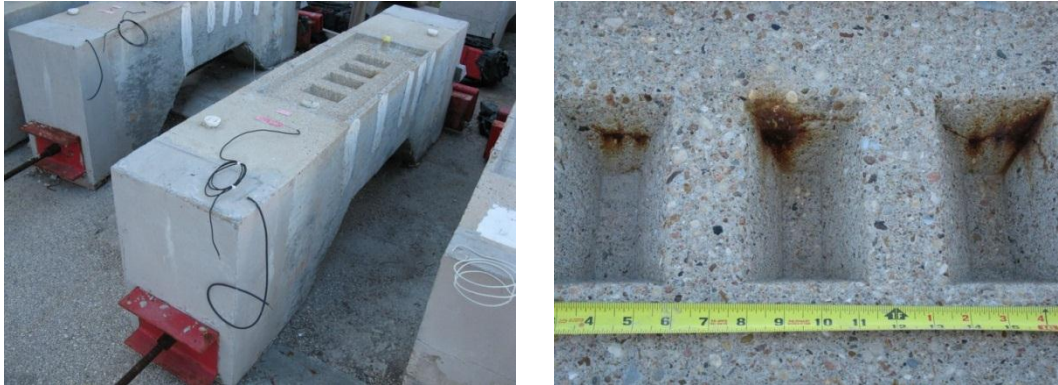
*Figure 5.106: Specimen 7.1 Overall (Left) and Corrosion Staining in Saltwater Tray Wells (Right)*
